PROTECTION OF STRUCTURAL STEEL
ON THE
P. R. R. Cortlandt Street Ferry Terminal
New York City

BULLETIN NO. 40

The Protection of Steel With Gunitite Without Reinforcing

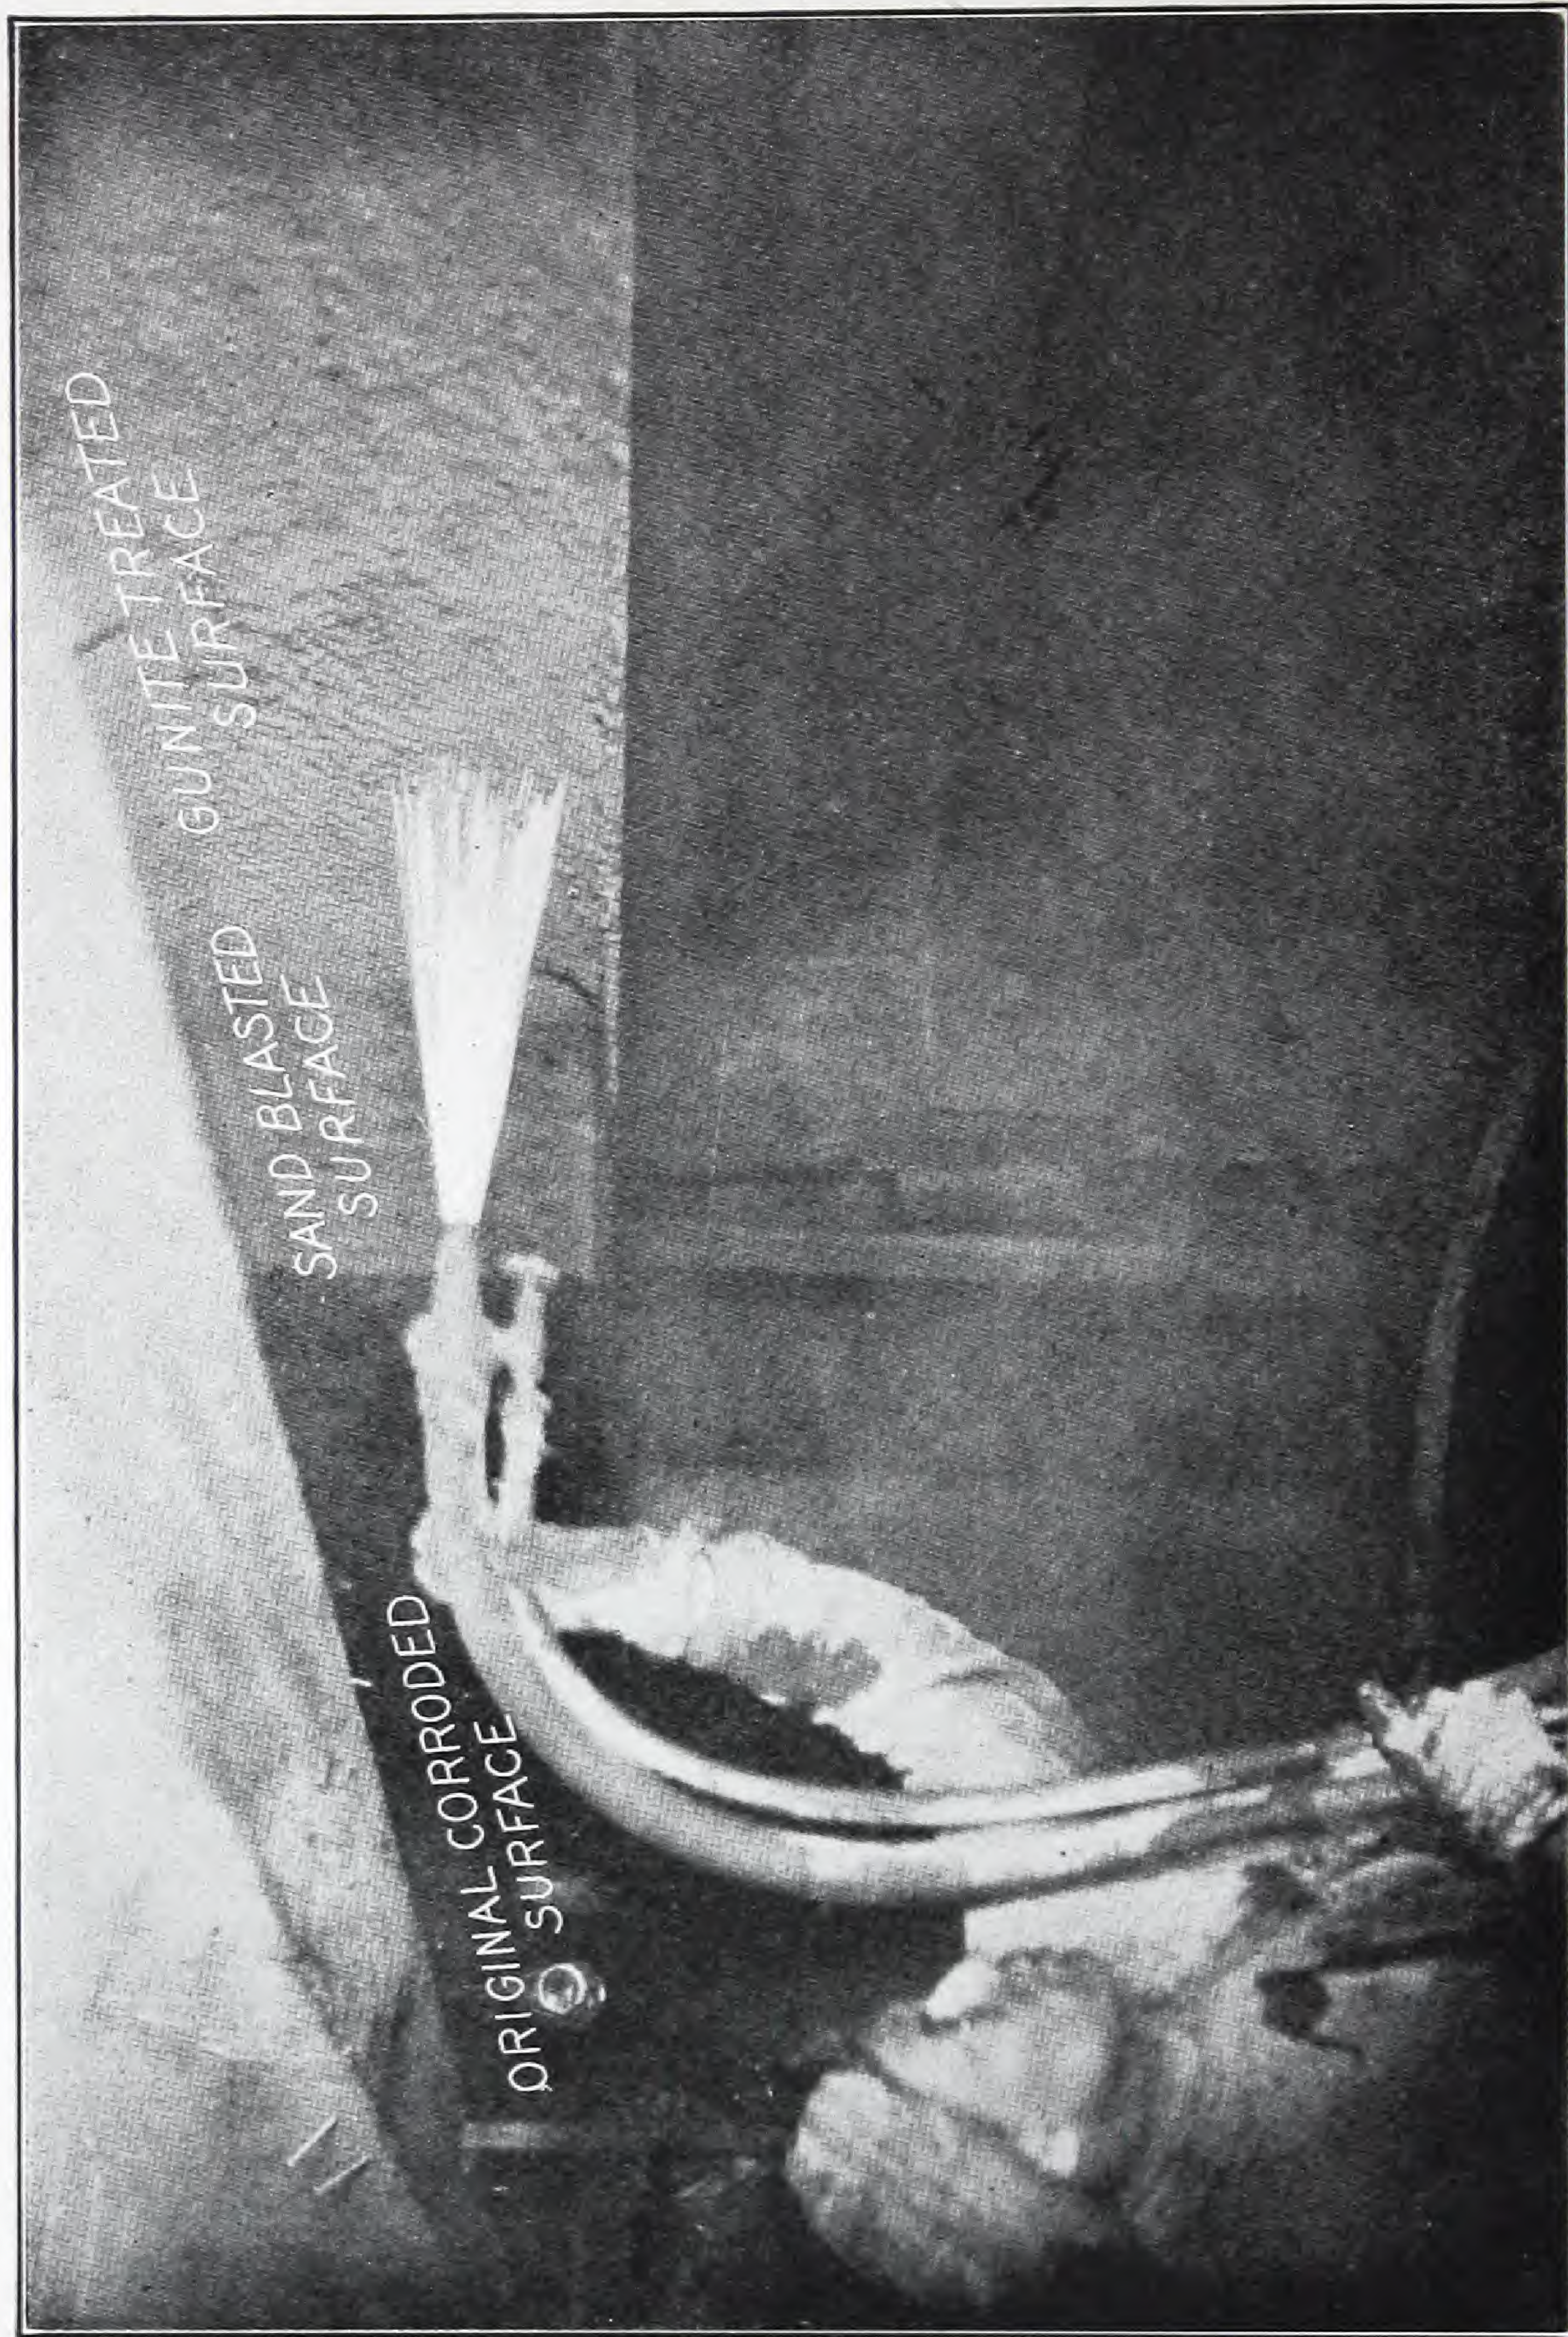
THE THREE STAGES OF THE WORK

Original Surface of Steel. Surface after Sand-blasting. The Gunit Protective Coating.

It was only a short time before the paint in this section had all come off, leaving the steel exposed. The steel was again cleaned and asphaltum tried, but this was a failure and in about six months it could be dusted off with a broom.

After this attempt, nothing was done in the way of a protective coating until after three years, when the railroad engineers examined the steel and found that some action had to be taken, as it was covered with a scale and rust that could easily be pulled off in layers about 3-32" thick. They consulted one of the engineers of the Cement-Gun Company, Inc., in reference to the problem, and he made them a proposal for doing the work which proved to be too expensive.

The above tests satisfied the railroad company that the proposition was practical, and an equipment was taken for the work, comprising two sand-blast machines and a Cement-Gun. All the steel was first sand-blasted to gray metal, and this coated with Guniting to a thickness varying from $\frac{1}{4}$ " to $\frac{1}{2}$ ". The work was started early in October, and completed about January 1, 1915. Examination of the work that has been completed for four months, and over which the heaviest loads have passed, shows no sign of cracking, and the ringing sound given forth when struck with a hammer, indicates the strong and perfect bond of the Guniting to the steel.
